Energy saving and artifact preservation in historic monumental buildings – church project

This research project concerns different aspects of energy saving in churches and similar buildings which constitute an important part of our cultural heritage, at the same time as preservation of historical and esthetical values is promoted. The project has particular focus on:

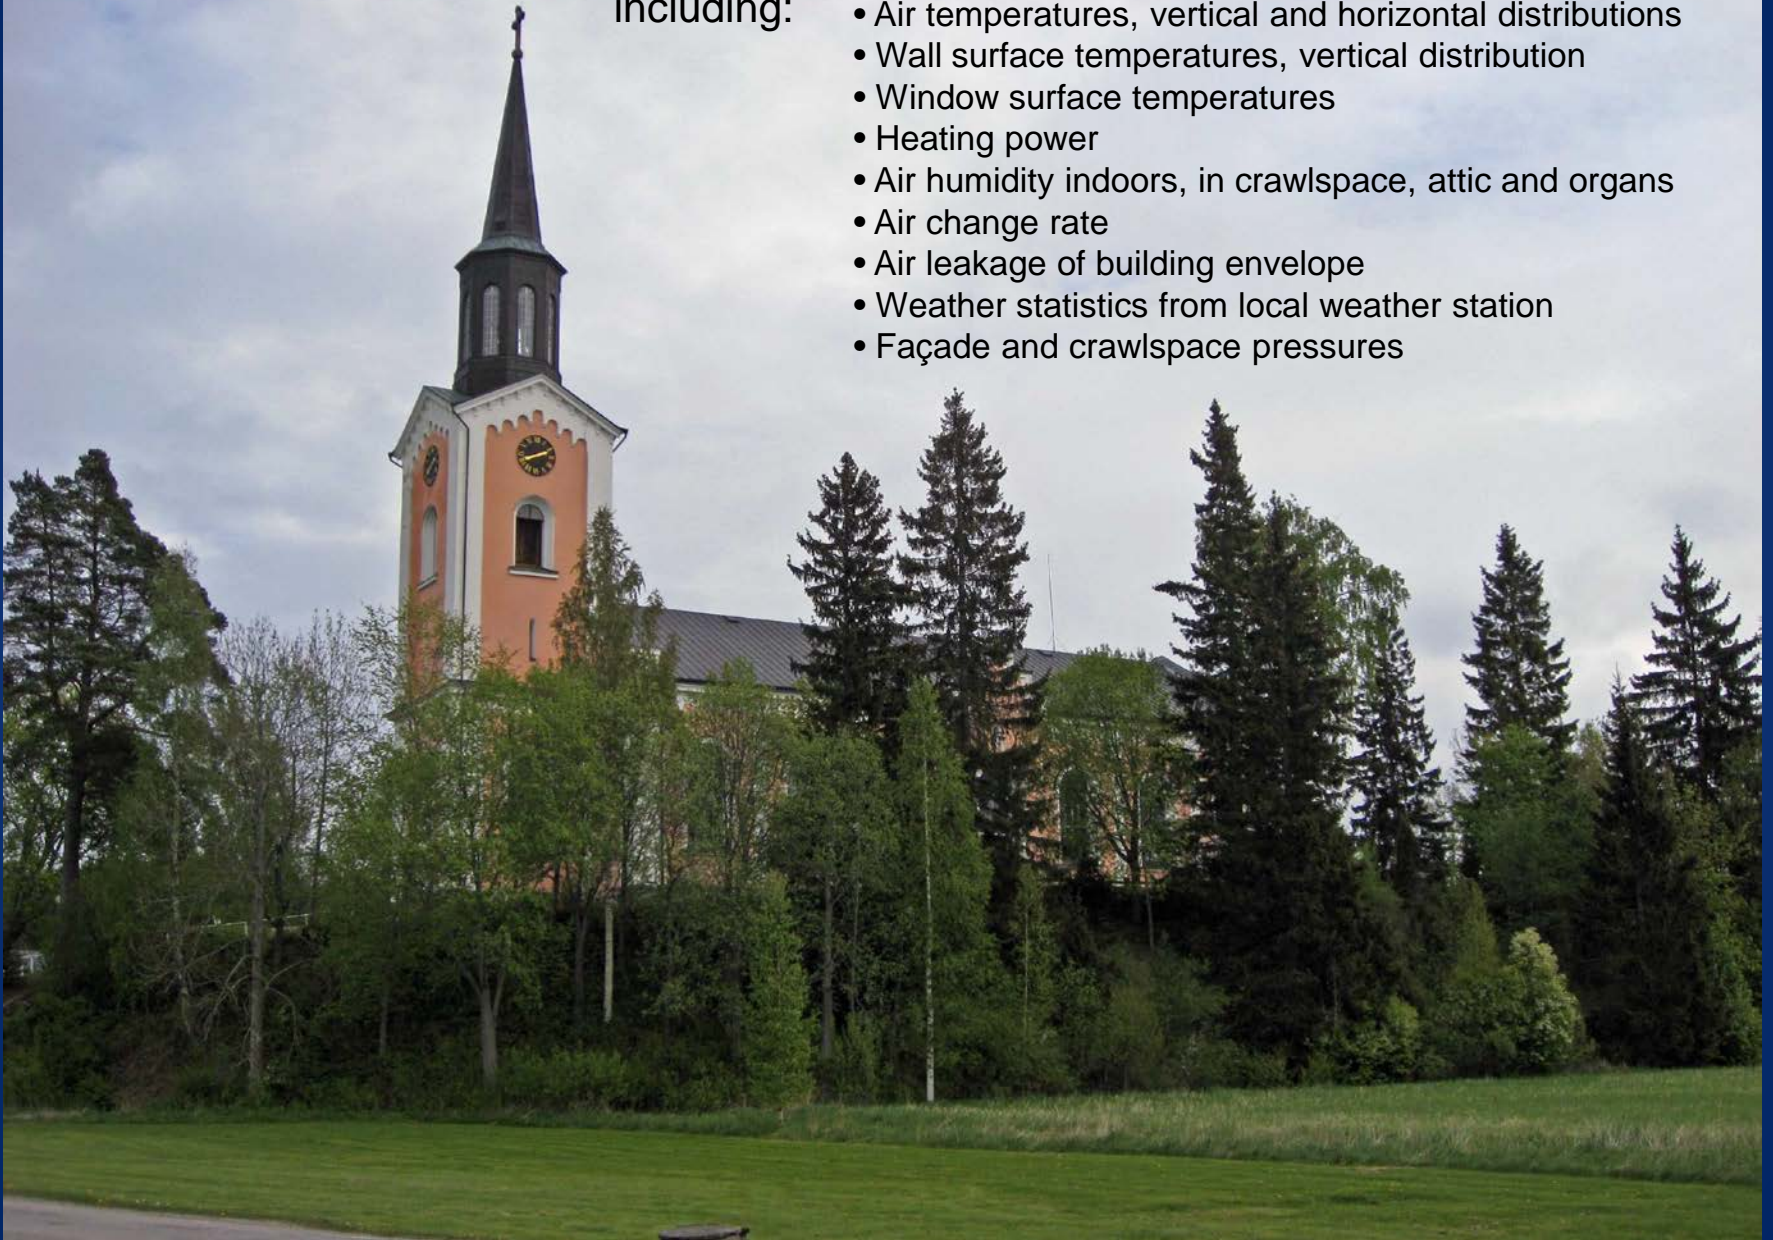
Hamrånge church where comprehensive long term measurements are performed, including:

- Air temperatures, vertical and horizontal distributions
- Wall surface temperatures, vertical distribution
- Window surface temperatures
- Heating power
- Air humidity indoors, in crawlspace, attic and organs
- Air change rate
- Air leakage of building envelope
- Weather statistics from local weather station
- Façade and crawlspace pressures

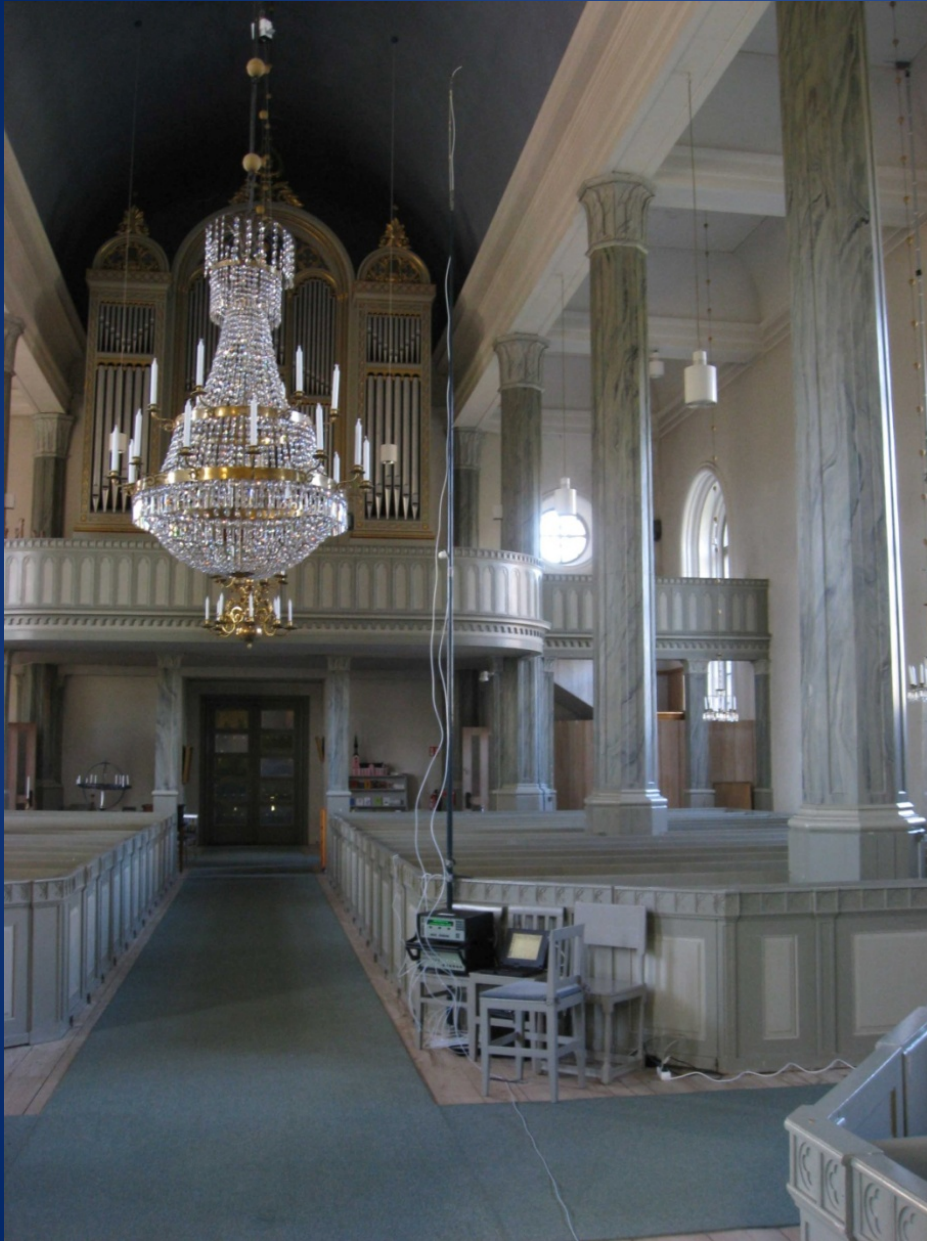
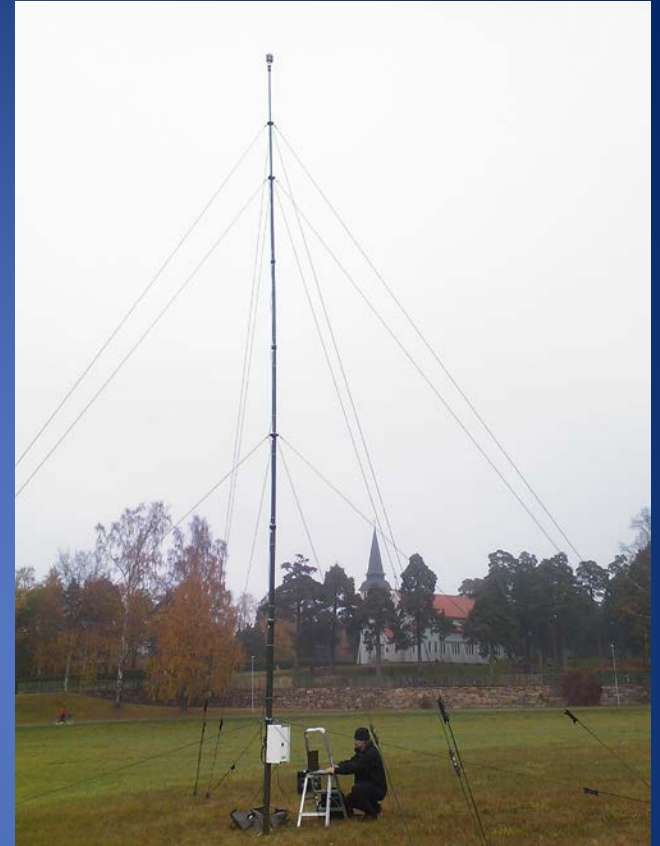
Tracer gas measurements for quantifying air change rate in a church (left) and a local weather mast (top) giving input data for air infiltration modelling.

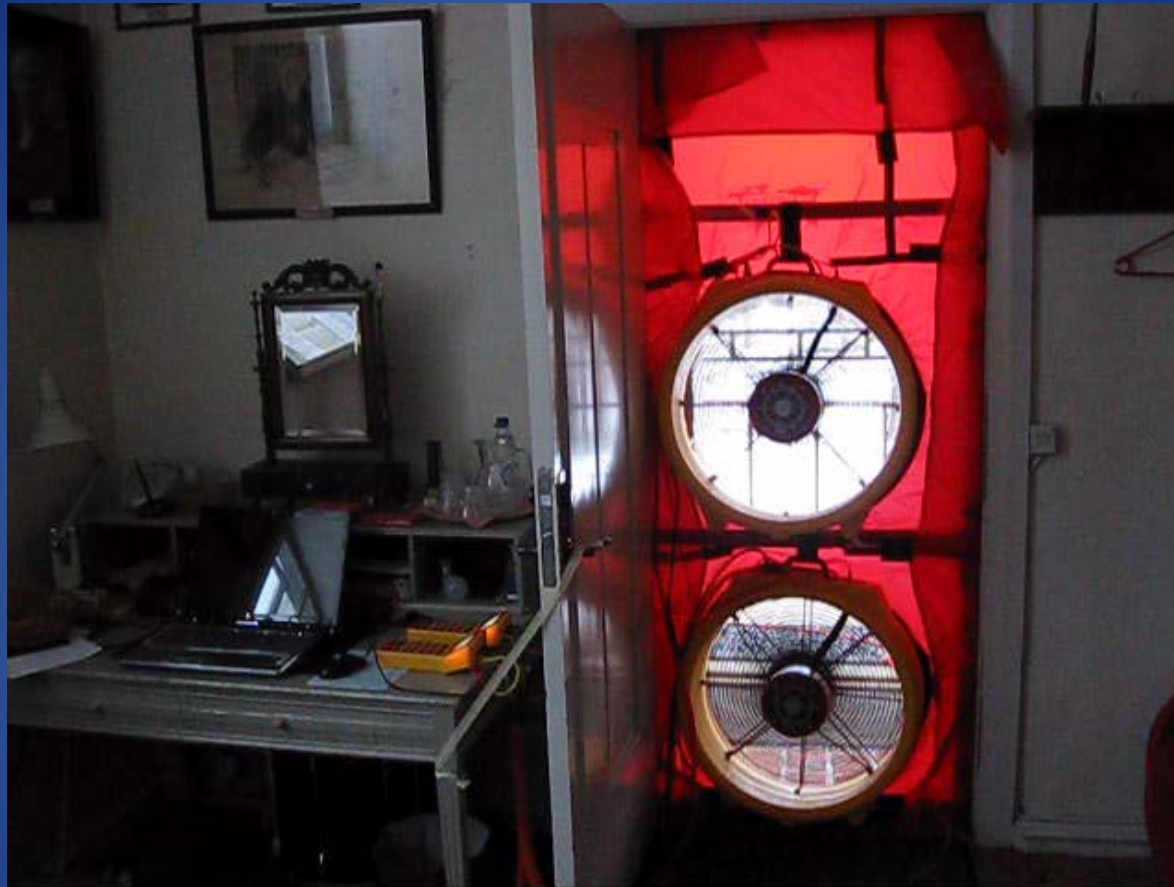
Measurement of the air leakage of the building envelope with standard *blower door* technique, here installed in the vestry of a church. With powerful fans the method seems practicable in most (Swedish) churches.

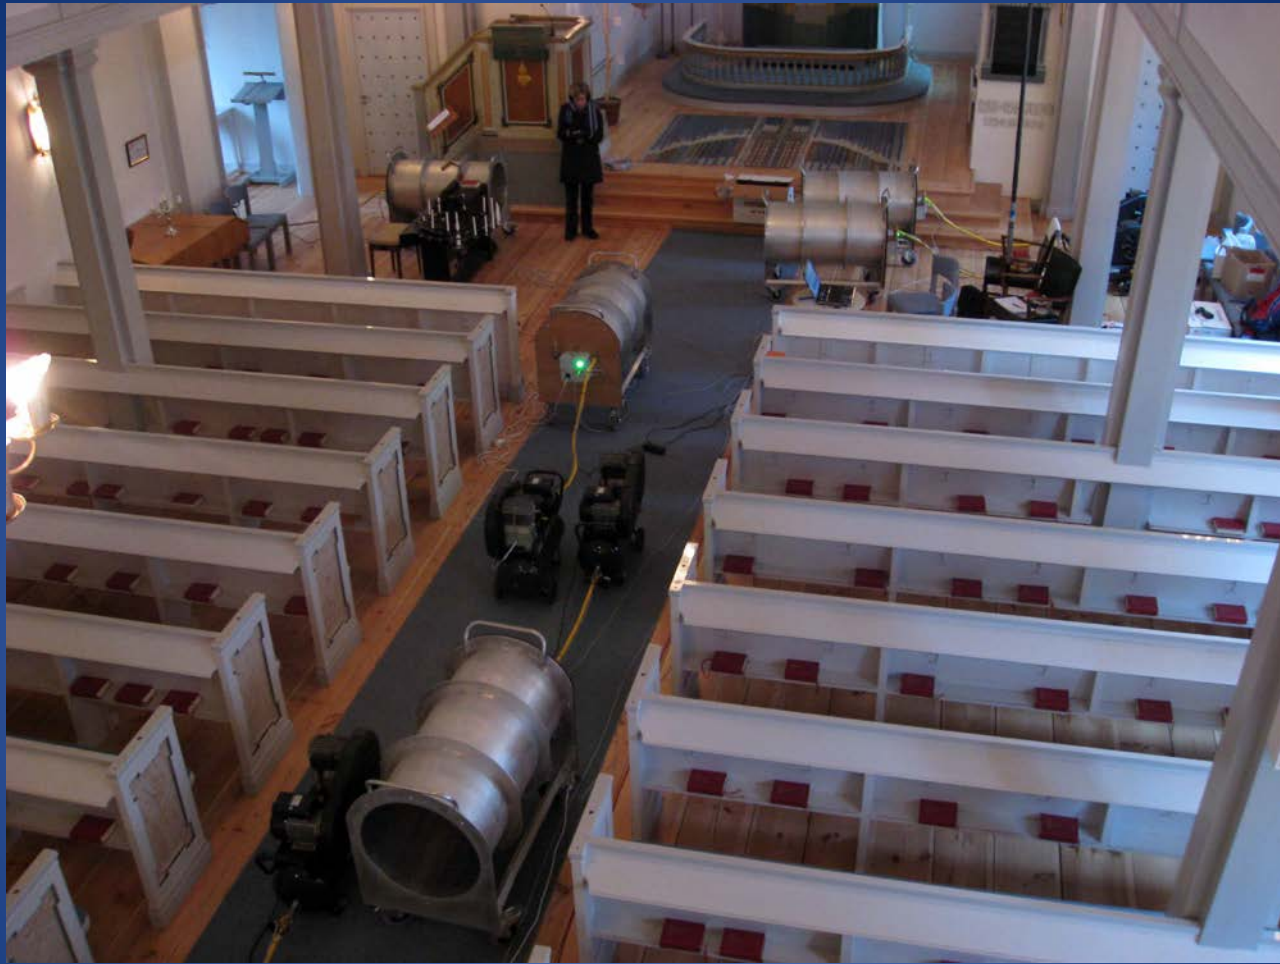
The *pressure pulse technique* for measuring air leakage of the building envelopes is being developed and evaluated in cooperation with University of Nottingham, UK. The technique is normally more accurate than the blower-door technique.

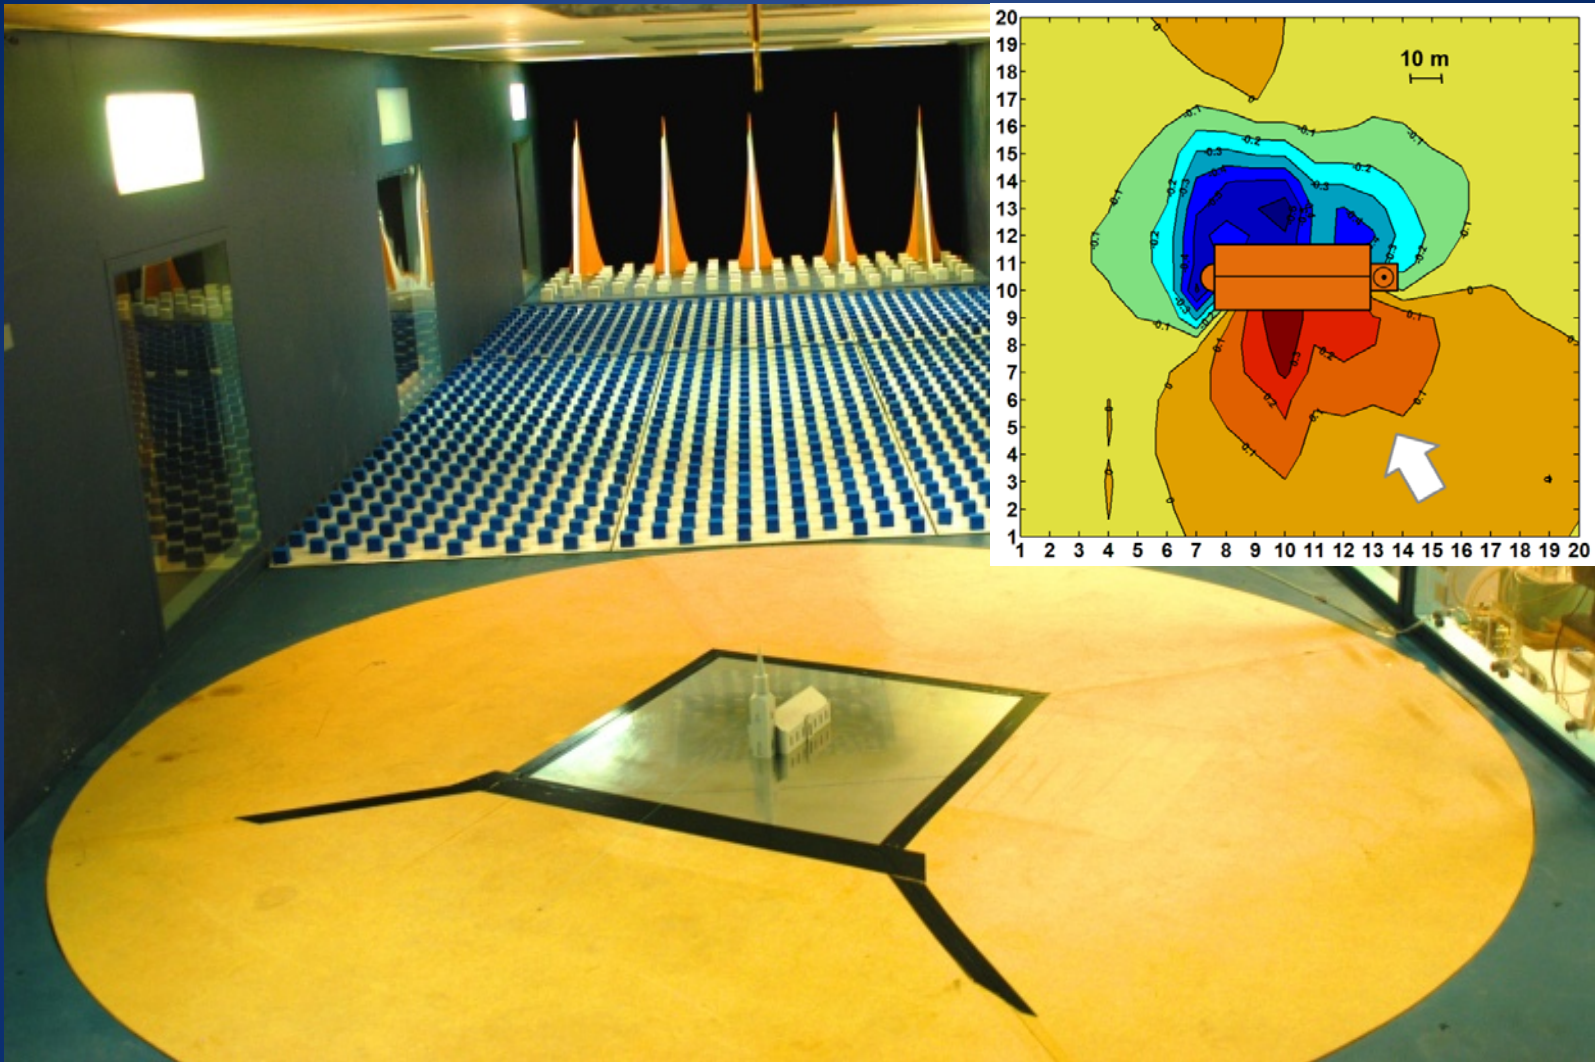
Wind tunnel used for measuring wind pressure distribution on the façade of a church model and on the surrounding ground. Top right: Example of pressure distribution occurring on ground at a certain wind angle.

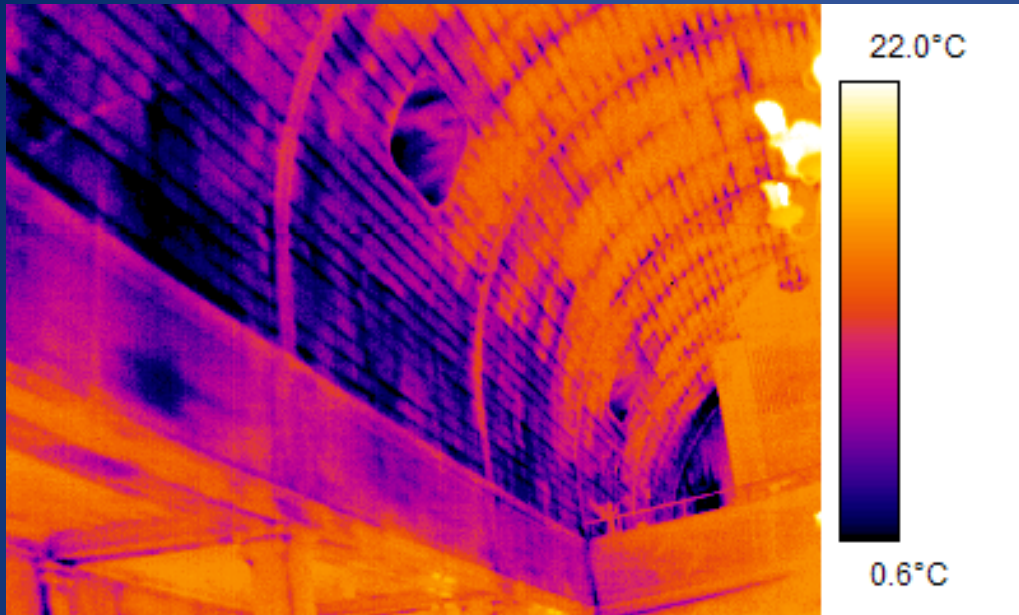
Air leakage spotting by infrared thermography (top, church ceiling) and particle measurements (right). Assisting under-pressure is attained in the whole church volume by means of blower-door fans.

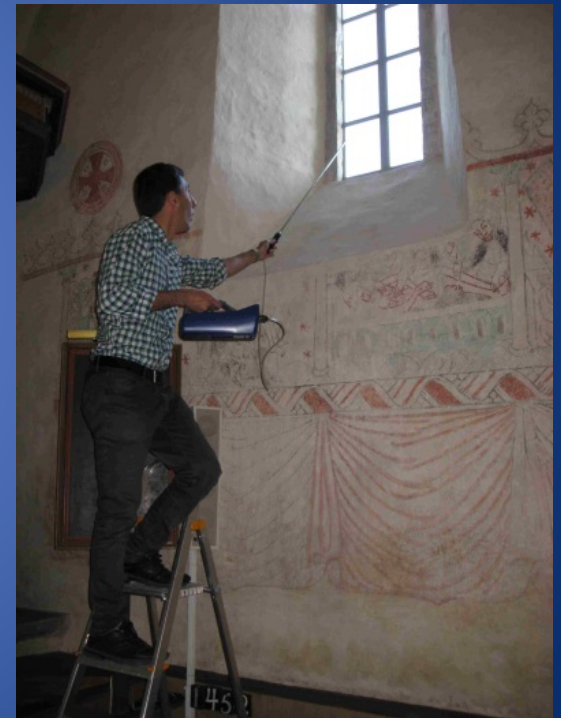
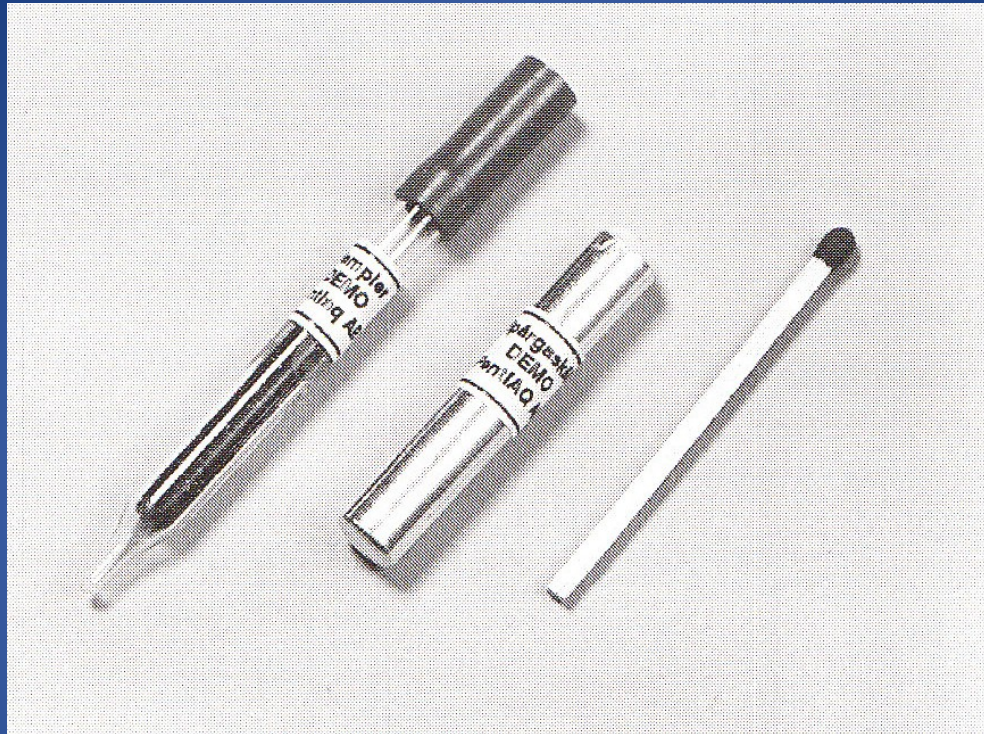
Passive tracer gas technique for measuring long term air change rate is evaluated. Small tracer gas samplers (left) and sources (right), are then distributed discretely within the church.

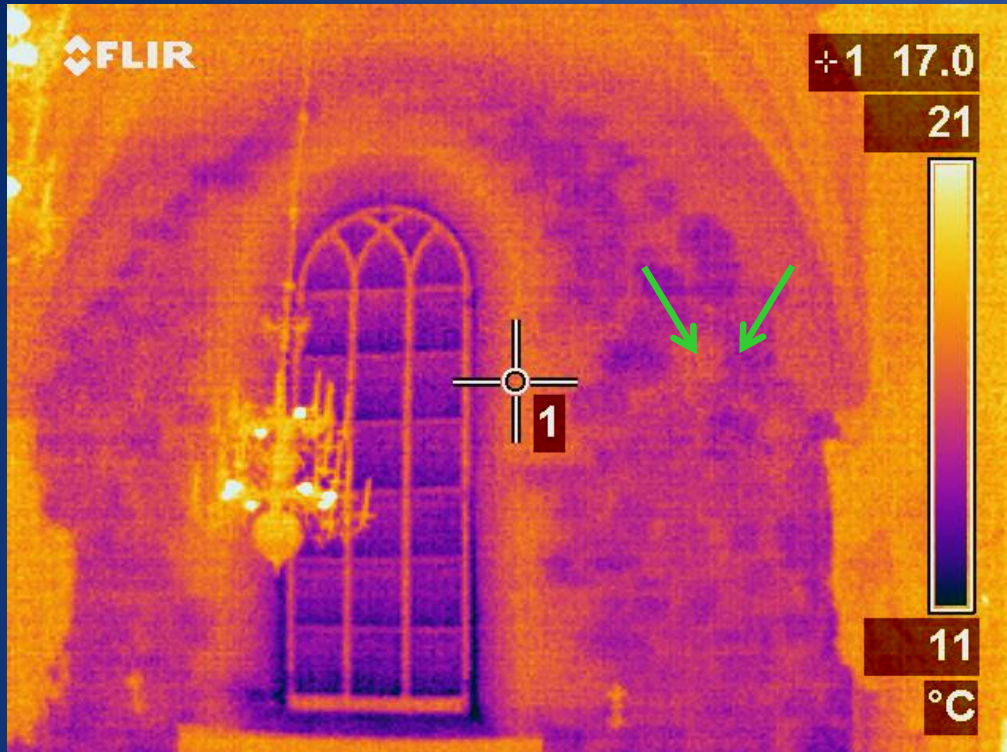
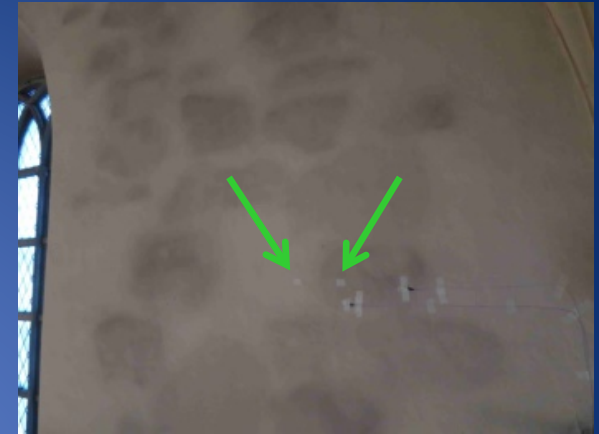
Airborne particles from infiltrated air, candle burning and visitors cause soiling of indoor surfaces, including historical artifacts. Enhanced particle deposition occurs on surfaces where there are cold bridges in the building construction – through the thermophoresis mechanism – like stones in the wall. IR-thermography indicating patch-patterned surface temperatures (left) and corresponding soiling pattern (right) with long term measurements taking place in two points of different temperatures and soiling rates.

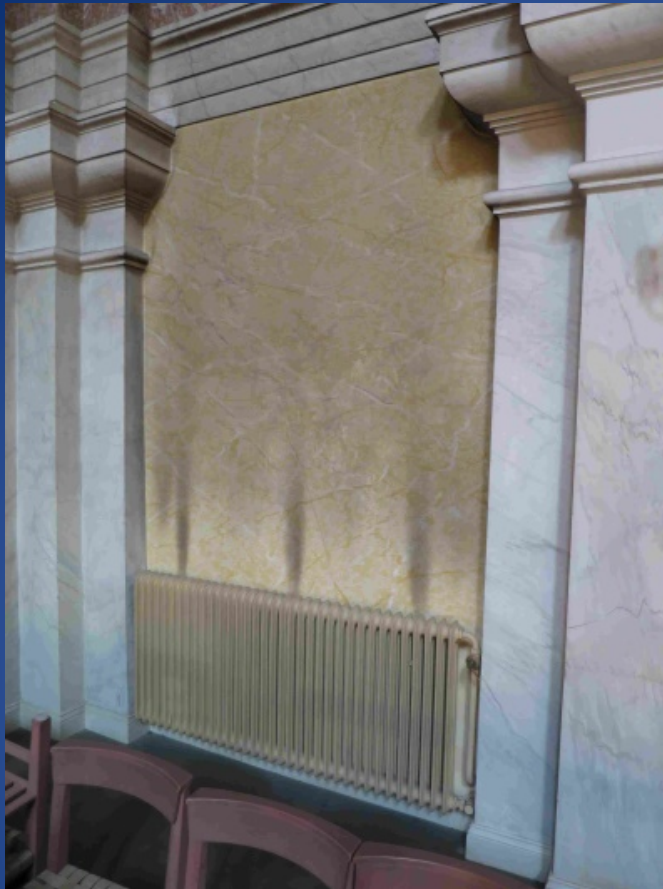
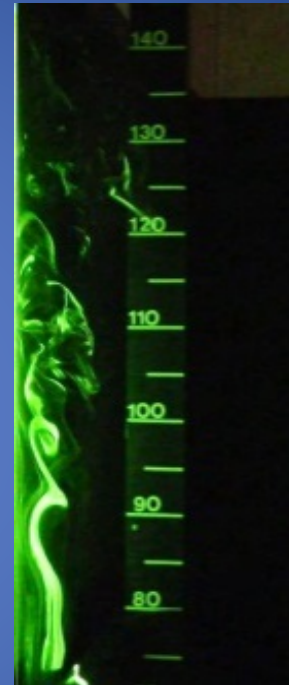
Wall surface soiling above a radiator (left) and visualization of the air flow pattern above a radiator (right). The warm, rising air flow from a radiator experiences a transition from laminar to turbulent flow at some distance above the radiator, coinciding with enhanced surface soiling. Small details like radiator mounting brackets trigger turbulence at an earlier stage, resulting in marked soiling stripes.

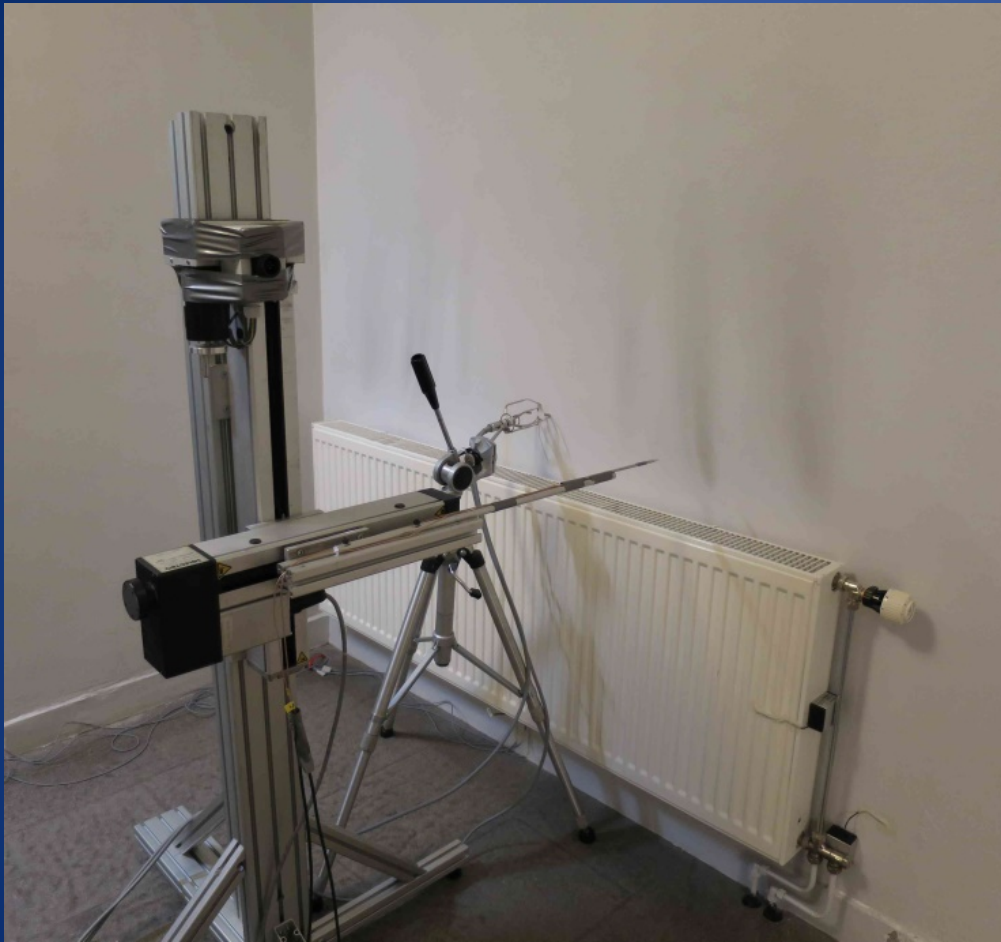
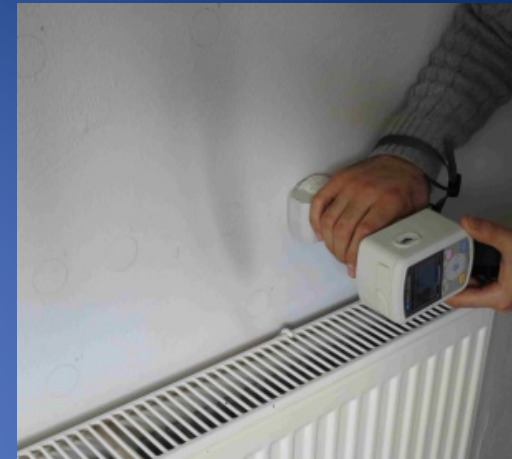
Measurements of the microclimate (left) and surface blackening (right) at the wall above a radiator. Verifies that air turbulence enhances surface soiling.

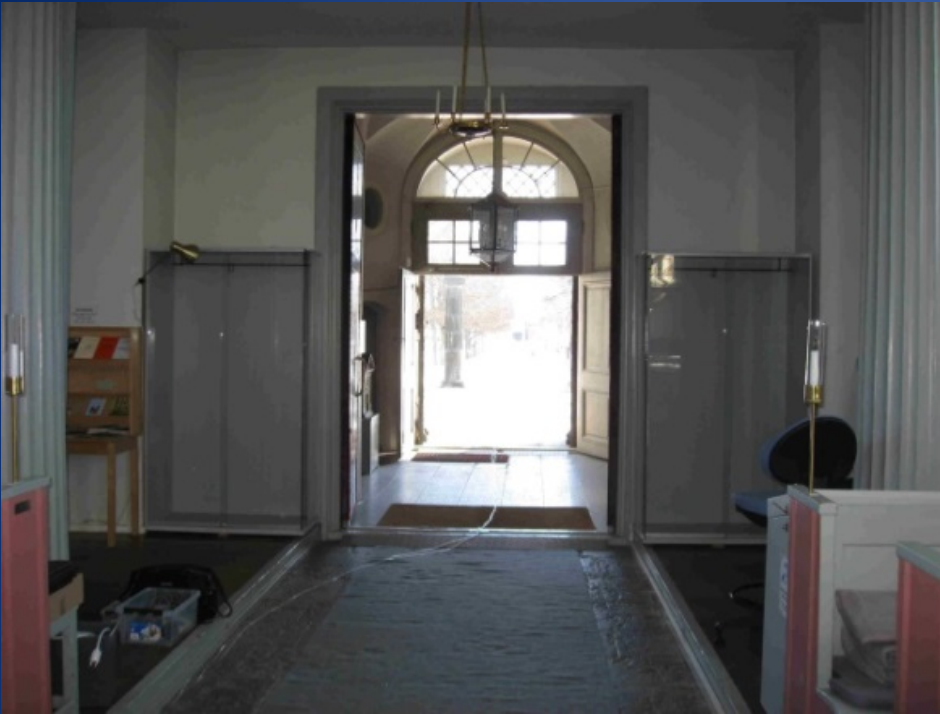
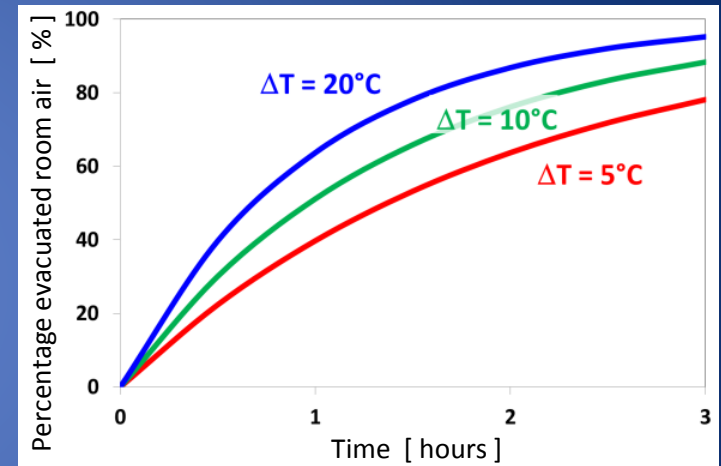
Intentionally enhanced airing of a church by opening the main porch. Tests with tracer gas measurements indicates that this is a practicable method to evacuate air pollutants, e.g. after a service occasion. The temporary heat loss is marginal. An airing guide has been produced; a typical airing diagram is shown on the right, where ΔT is the indoor-outdoor temperature difference.

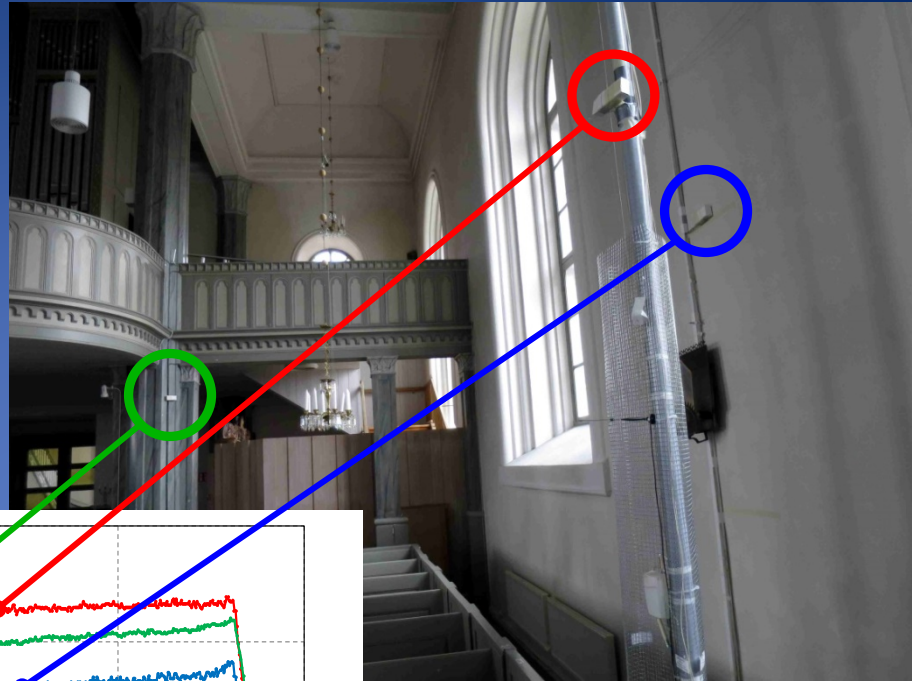
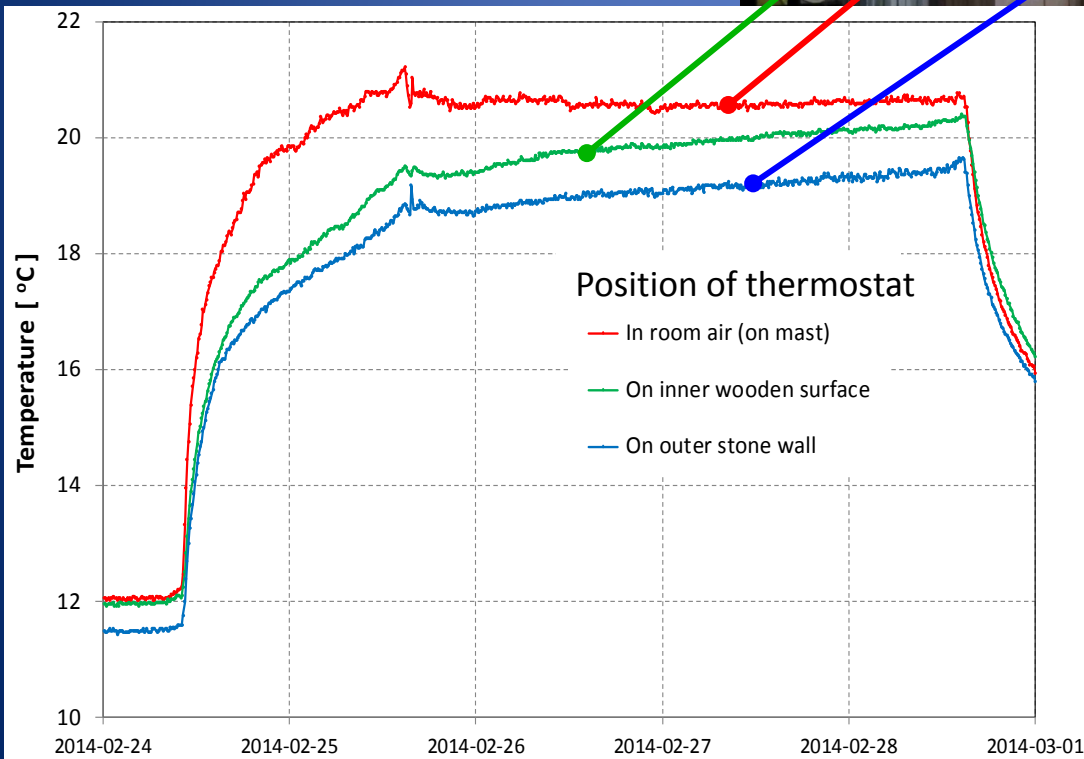
Test of different thermostat placing. Diagram showing a heating-up event. Placing on outer stone wall reduces reaction time and yields lower temperature readings, complicating temperature regulation.

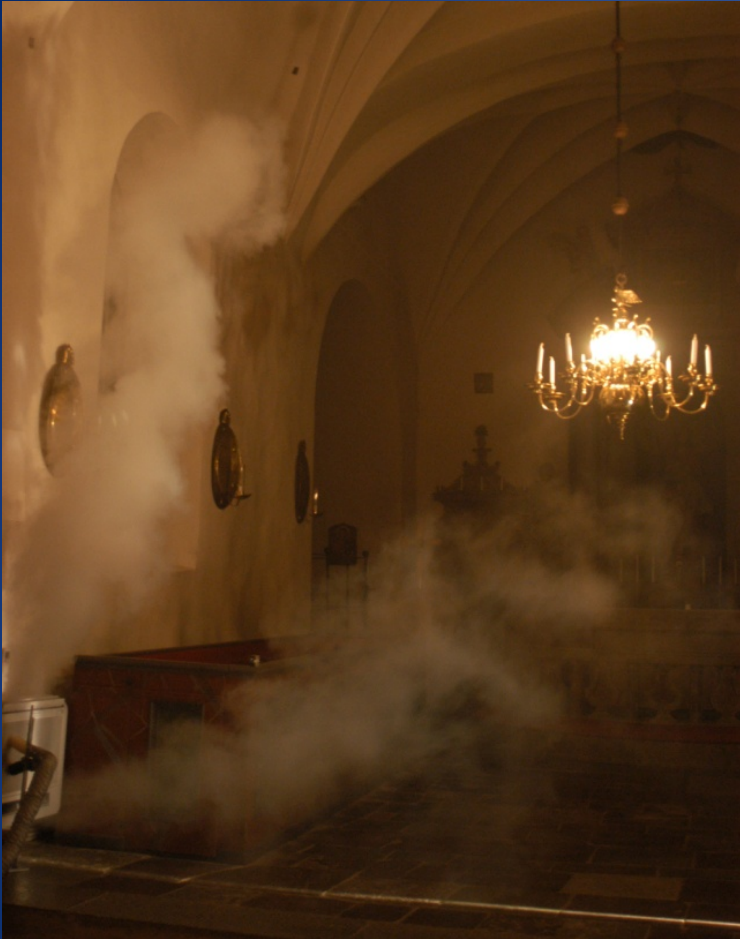
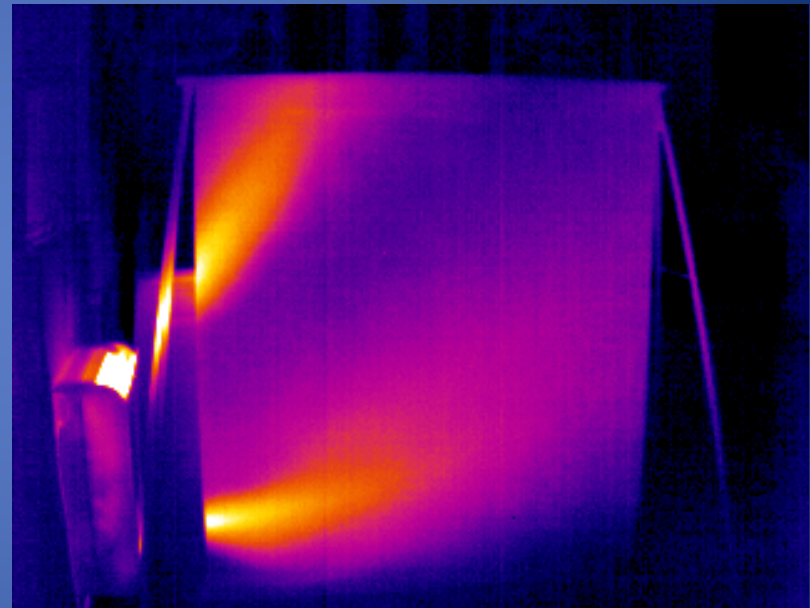
Smoke and IR visualization of supply air current from the fan convector of an air-to-air heat pump in a church.

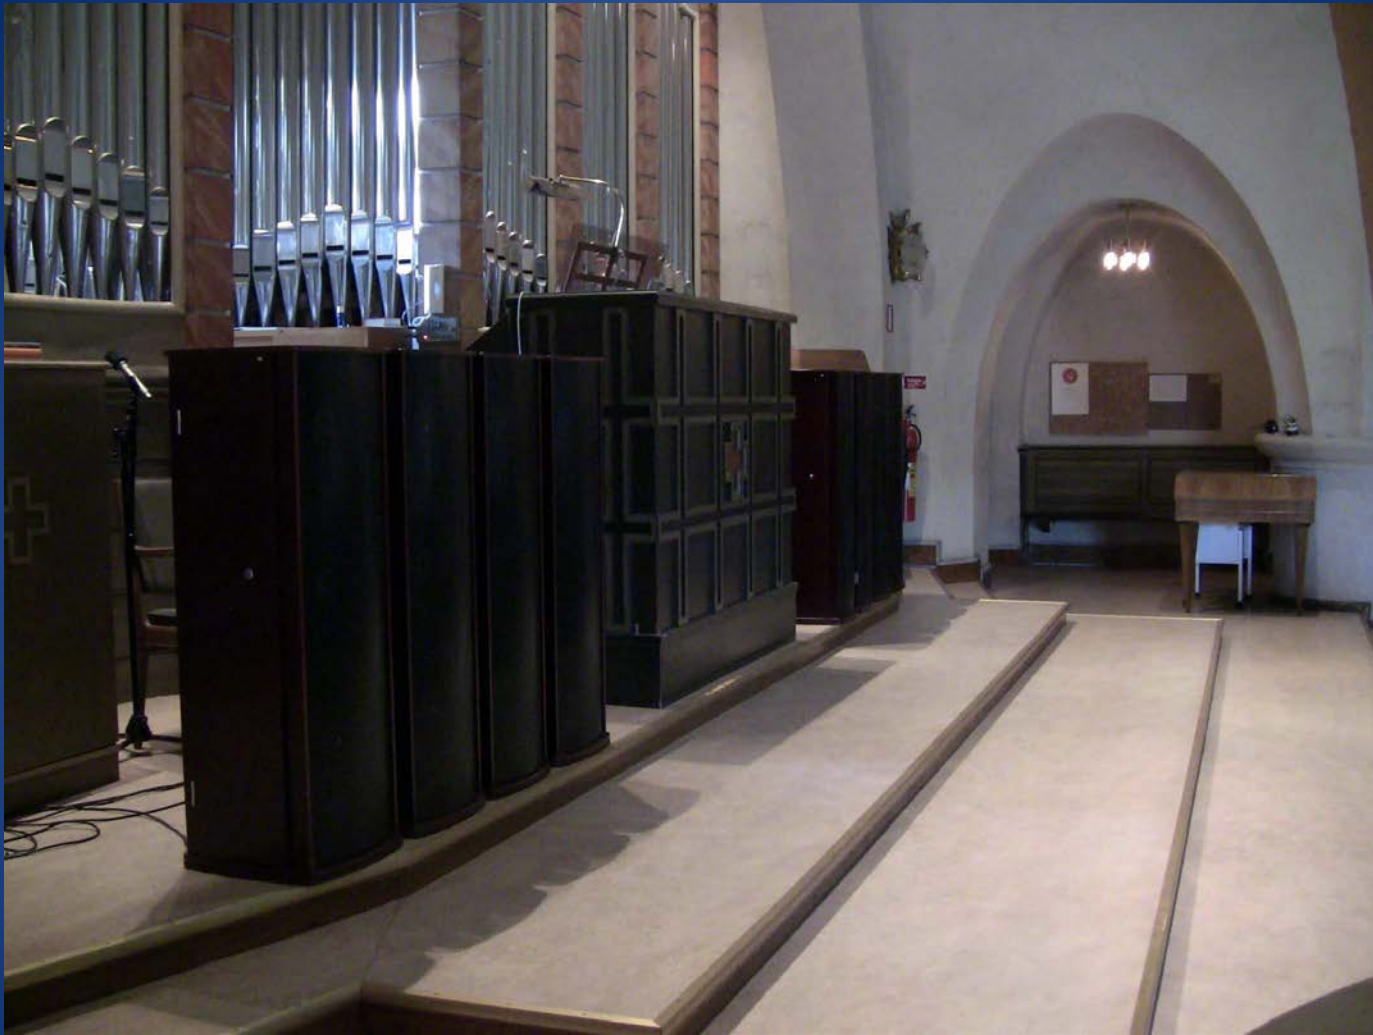
Particulate air cleaning: Eight stand-alone air cleaners assembled on the balcony of a church. Measurements have indicated effective reduction of the amount of airborne particles.

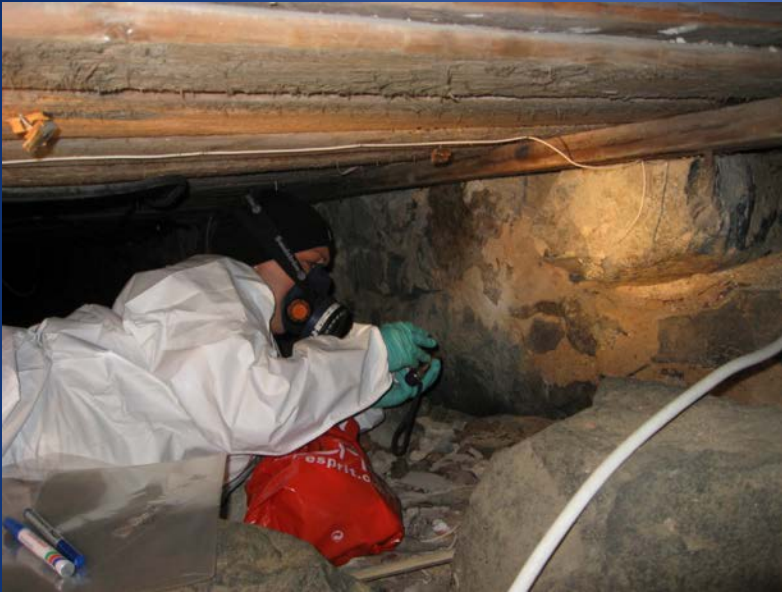
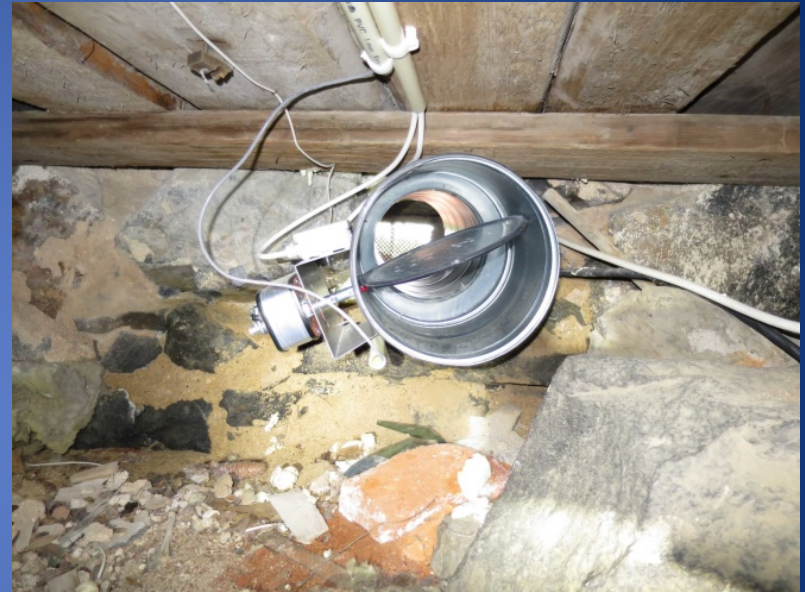
Crawl space ventilation strategies and effects on dampness are tested. On the right, a humidity-controlled damper in a crawl space vent.
