Energy saving and artifact preservation in historic monumental buildings – church project

This research project concerns different aspects of energy saving in churches and similar buildings which constitute an important part of our cultural heritage, at the same time as preservation of historical and esthetical values is promoted. The project has particular focus on:

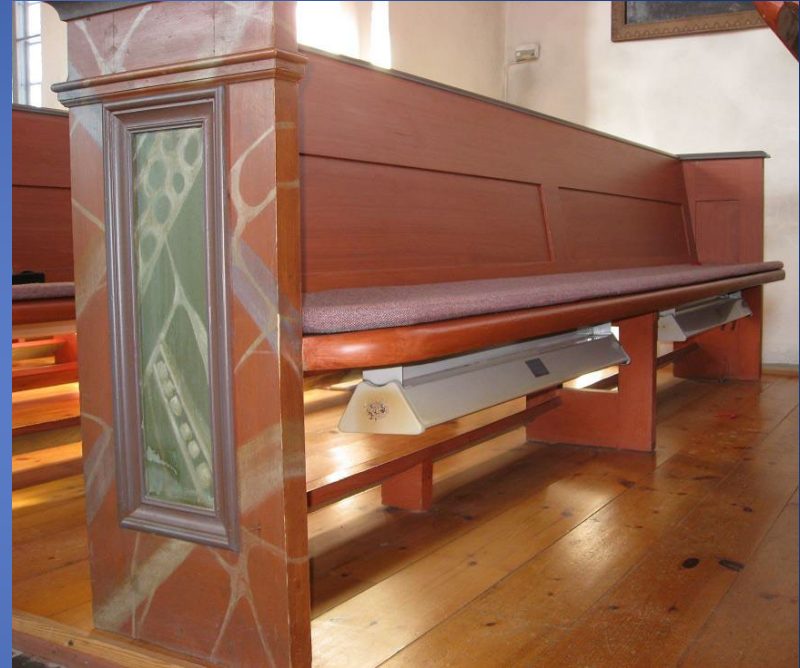
Hamrånge church where comprehensive long term measurements are performed, including:

- Air temperatures, vertical and horizontal distributions
- Wall surface temperatures, vertical distribution
- Window surface temperatures
- Heating power
- Air humidity indoors, in crawlspace, attic and organs
- Air change rate
- Air leakage of building envelope
- Weather statistics from local weather station
- Façade and crawlspace pressures

Swedish churches are usually heated by direct electricity radiators and/or bench heaters. Convective air currents from these, and downdraughts along walls and windows are responsible for most of the air movements in churches. These air movements, in turn, affect heat distribution and thermal comfort, but also deposition of airborne particles on surfaces.

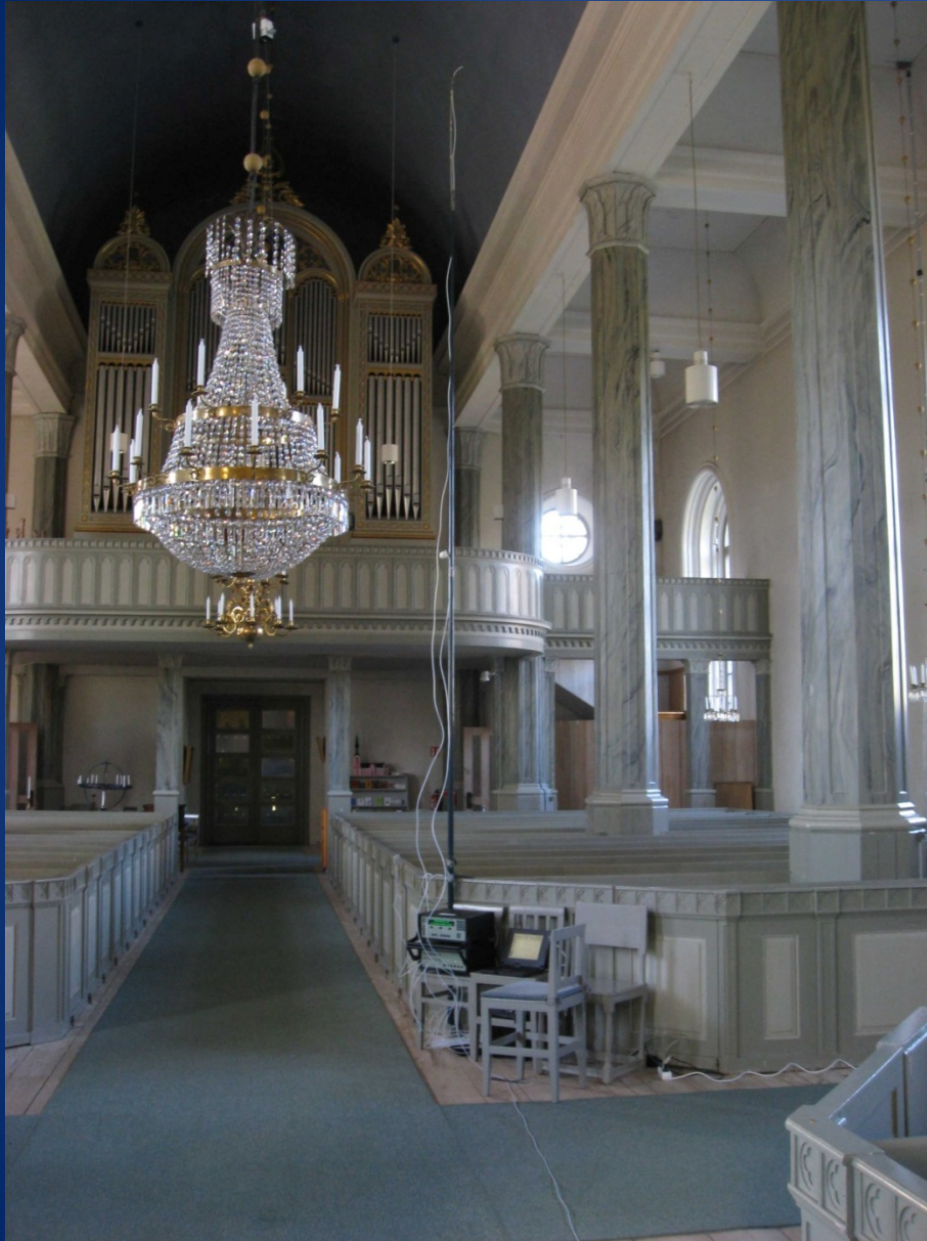
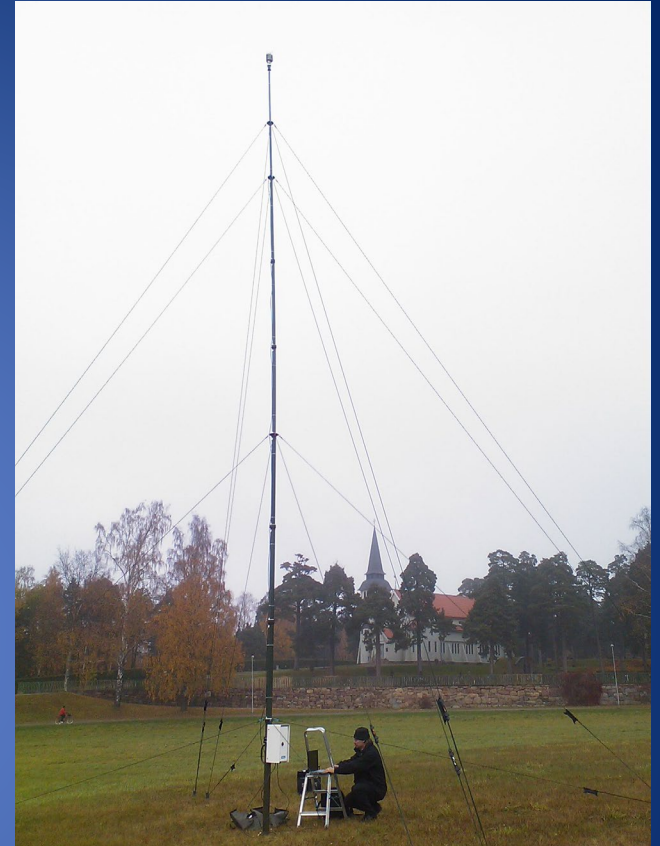
Tracer gas measurements for quantifying air change rate in a church (left) and a local weather mast (top) giving input data for air infiltration modelling.

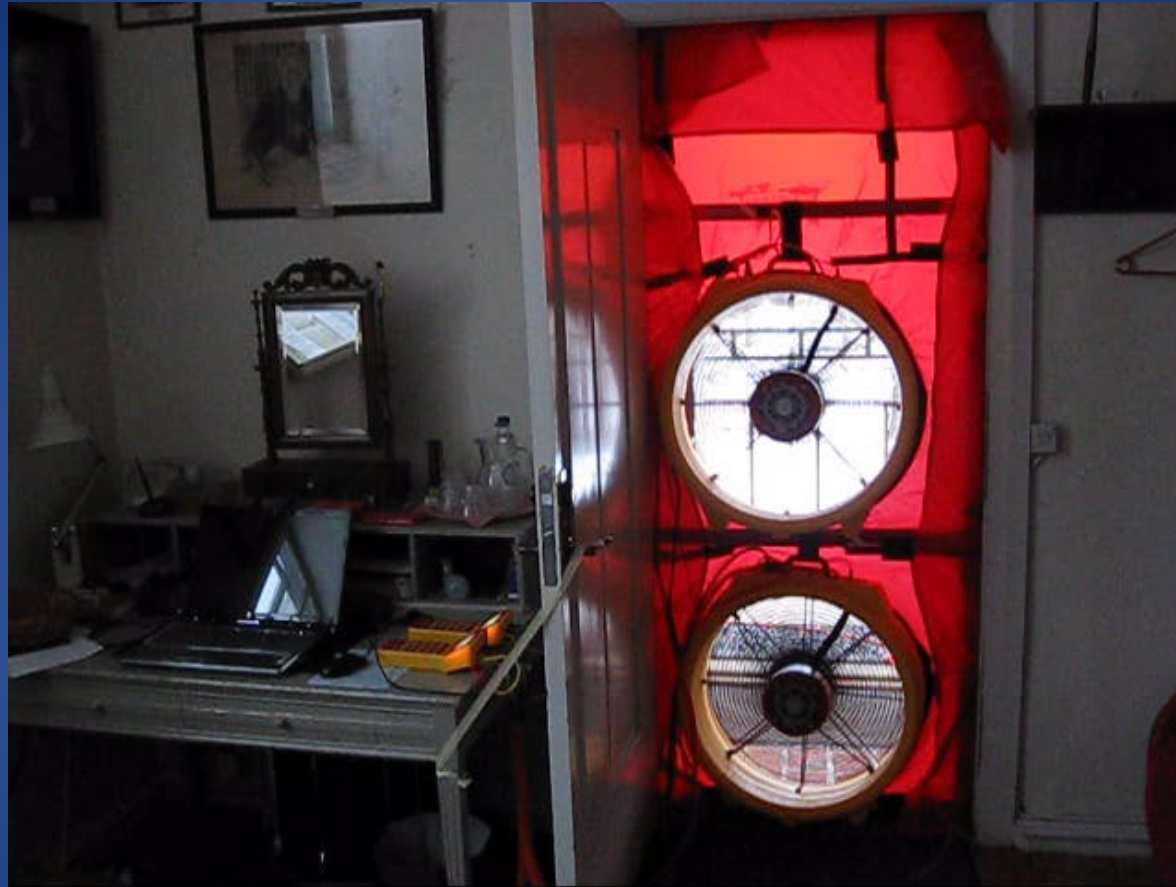
Measurement of the air leakage of the building envelope with standard *blower door* technique, here installed in the vestry of a church. With powerful fans the method seems practicable in most (Swedish) churches.

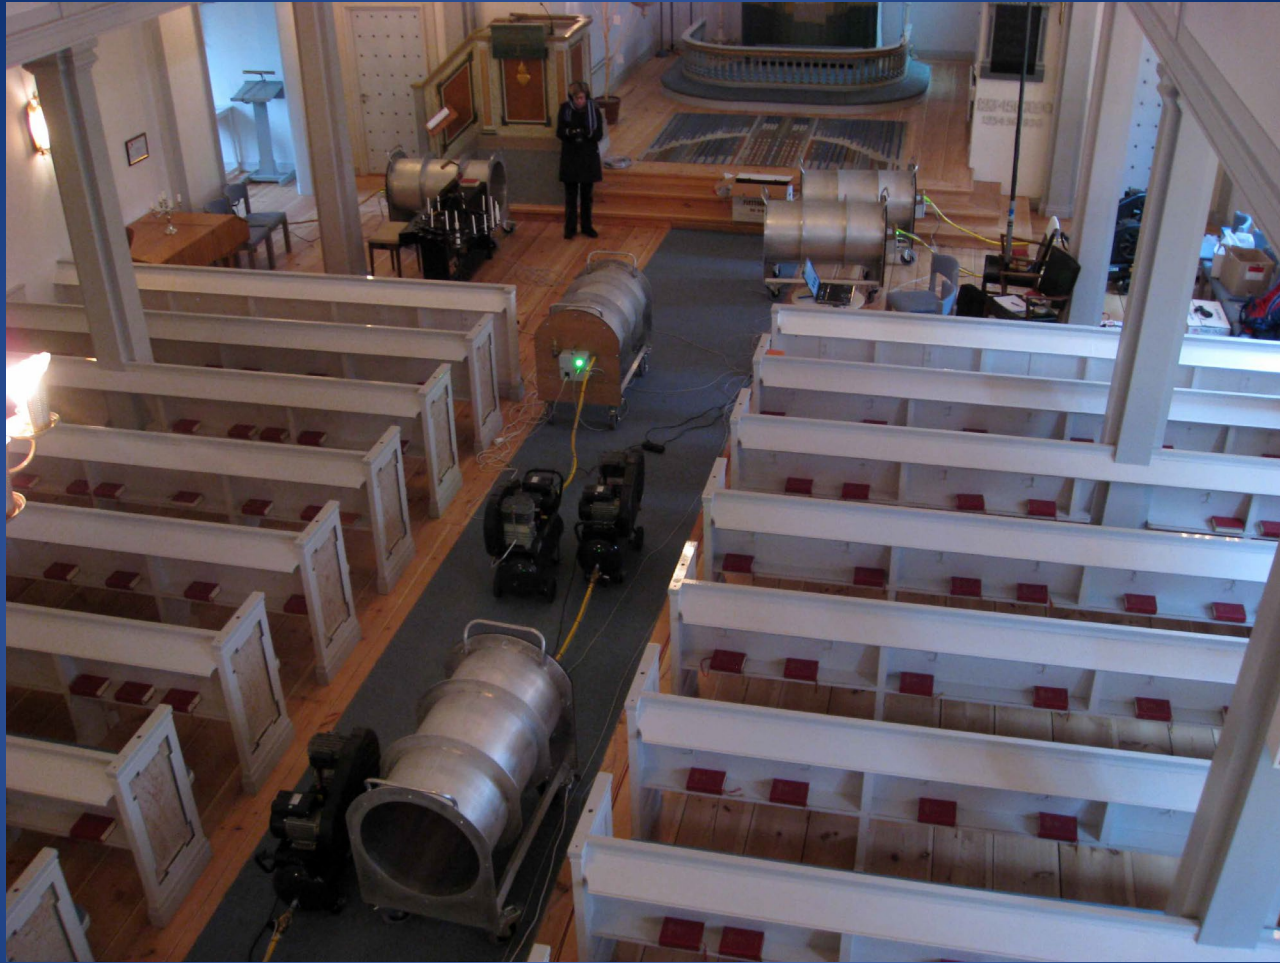
The *pressure pulse technique* for measuring air leakage of the building envelopes is being developed and evaluated in cooperation with University of Nottingham, UK. The technique is normally more accurate than the blower-door technique.

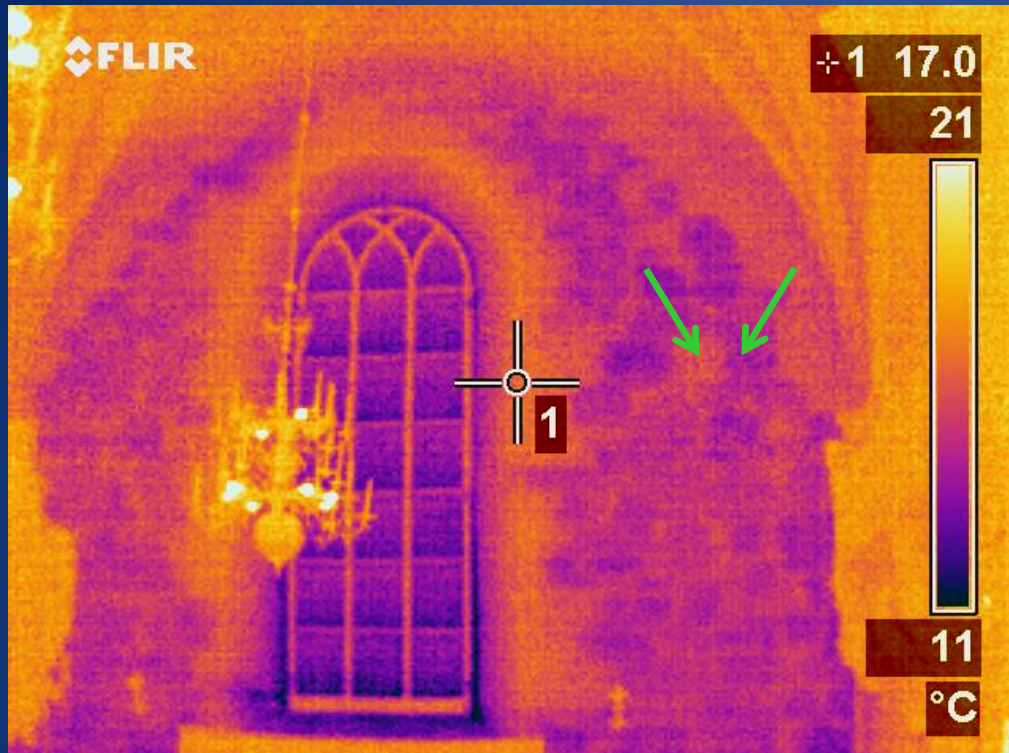
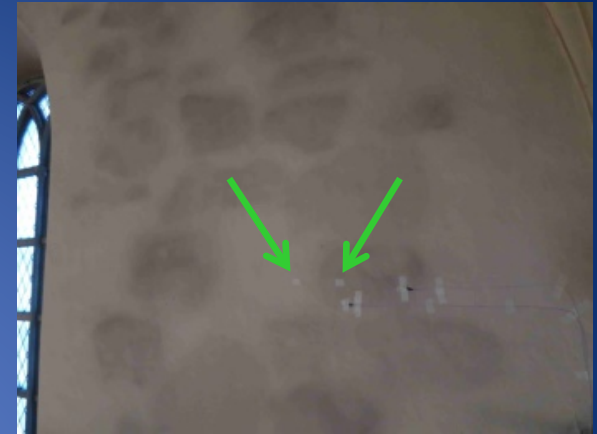
Airborne particles from infiltrated air, candle burning and visitors cause soiling of indoor surfaces, including historical artifacts. Enhanced particle deposition occurs on surfaces where there are cold bridges in the building construction – through the thermophoresis mechanism – like stones in the wall. IR-thermography indicating patch-patterned surface temperatures (left) and corresponding soiling pattern (right) with long term measurements taking place in two points of different temperatures and soiling rates.

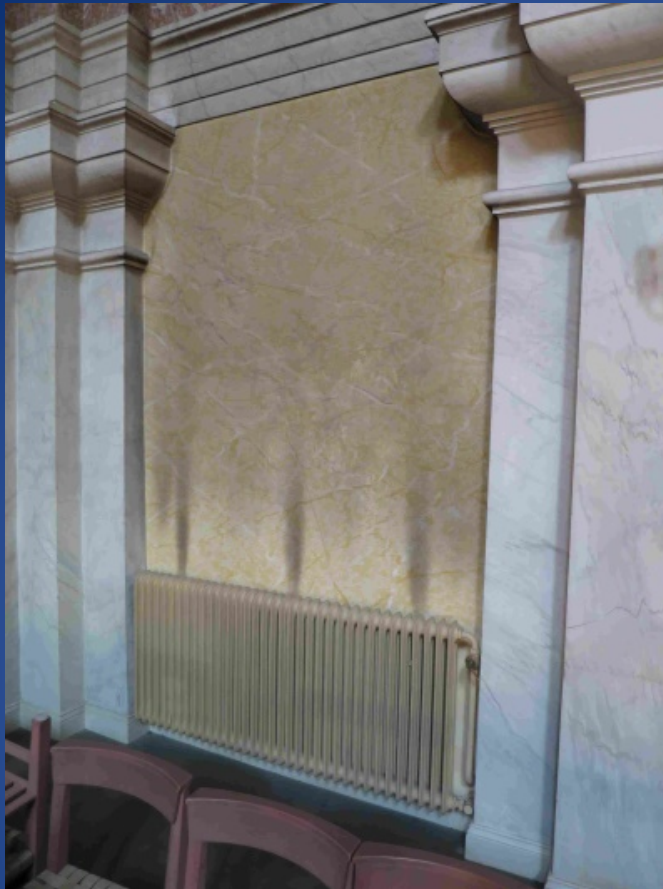
Wall surface soiling above a radiator (left) and visualization of the air flow pattern above a radiator (right). The warm, rising air flow from a radiator experiences a transition from laminar to turbulent flow at some distance above the radiator, coinciding with enhanced surface soiling. Small details like radiator mounting brackets trigger turbulence at an earlier stage, resulting in marked soiling stripes.

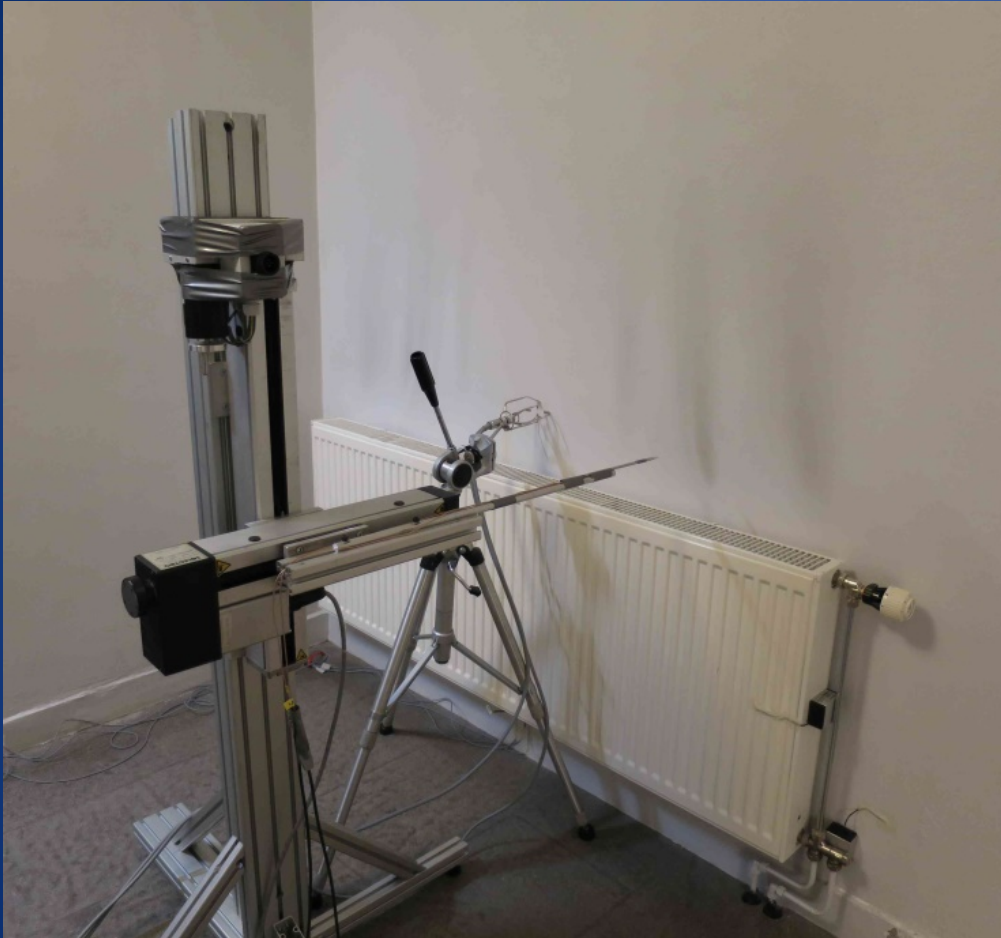
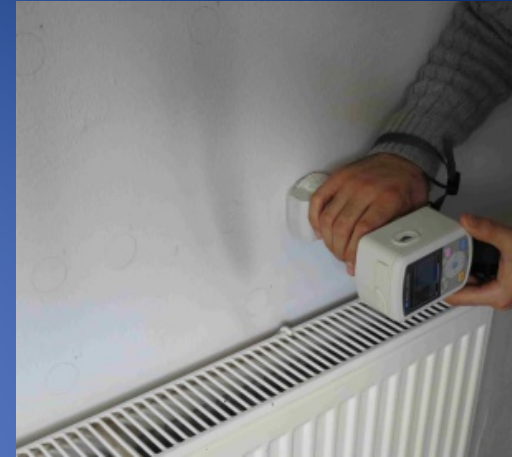
Measurements of the microclimate (left) and surface blackening (right) at the wall above a radiator. Verifies that air turbulence enhances surface soiling.

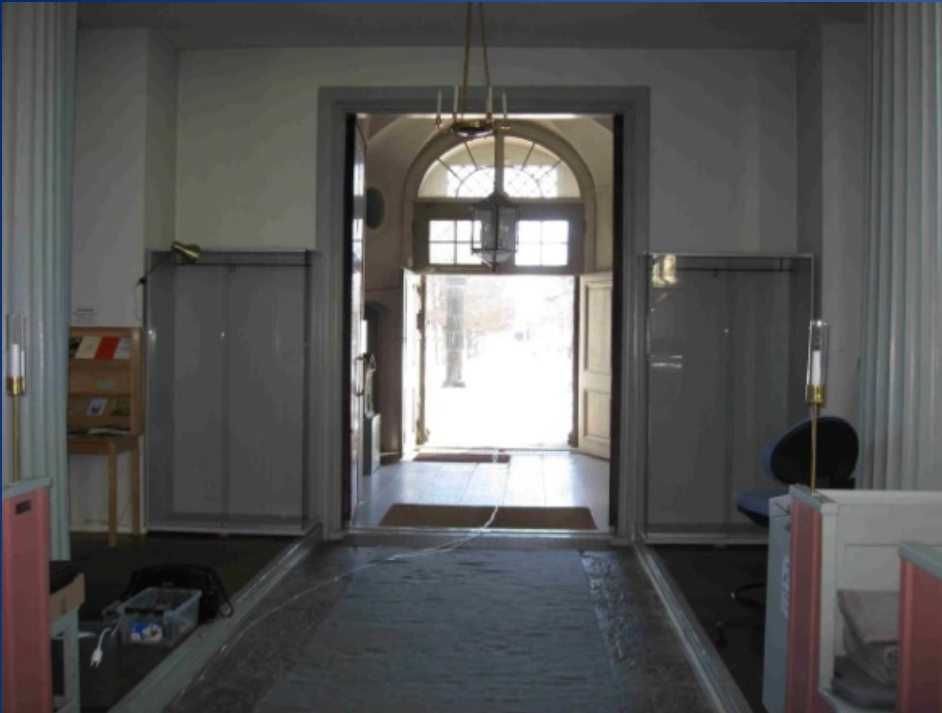
Intentionally enhanced airing of a church by opening the main porch. Tests with tracer gas measurements indicates that this is a practicable method to evacuate air pollutants, e.g. after a service occasion. The temporary heat loss is marginal. An airing guide has been produced; a typical airing diagram is shown on the right, where ΔT is the indoor-outdoor temperature difference.

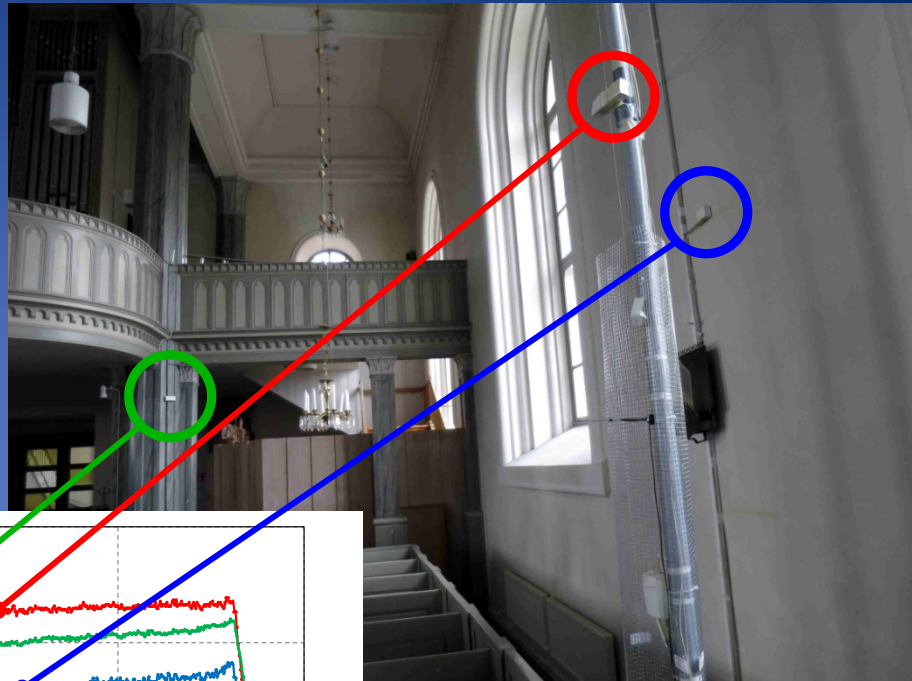
Test of different thermostat placing. Diagram showing a heating-up event. Placing on outer stone wall reduces reaction time and yields lower temperature readings, complicating temperature regulation.

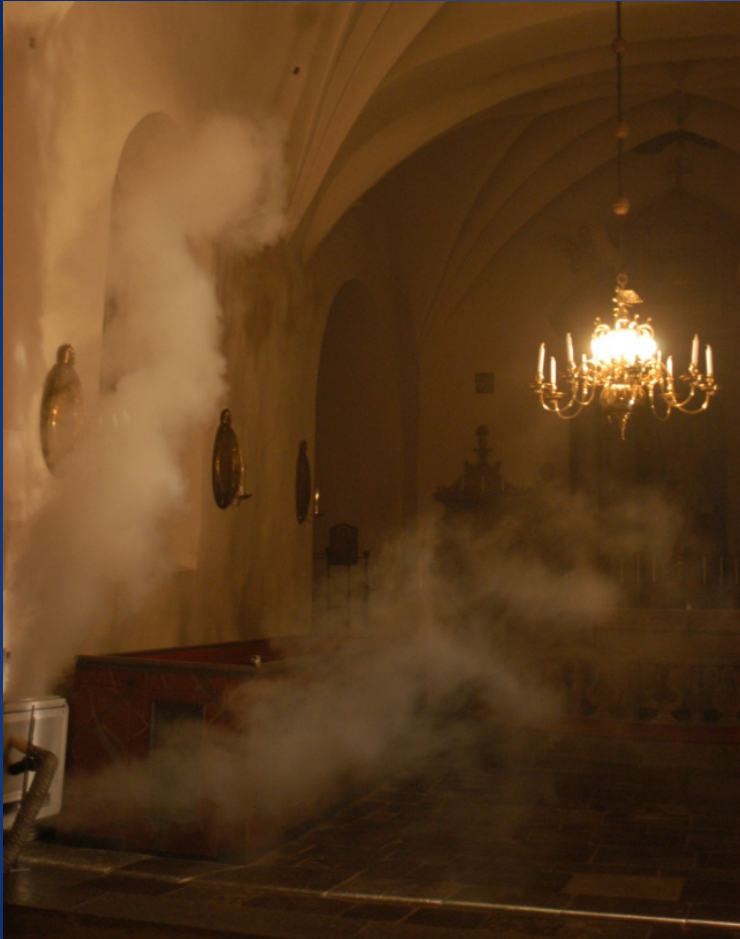
Smoke and IR visualization of supply air current from the fan convector of an air-to-air heat pump in a church.

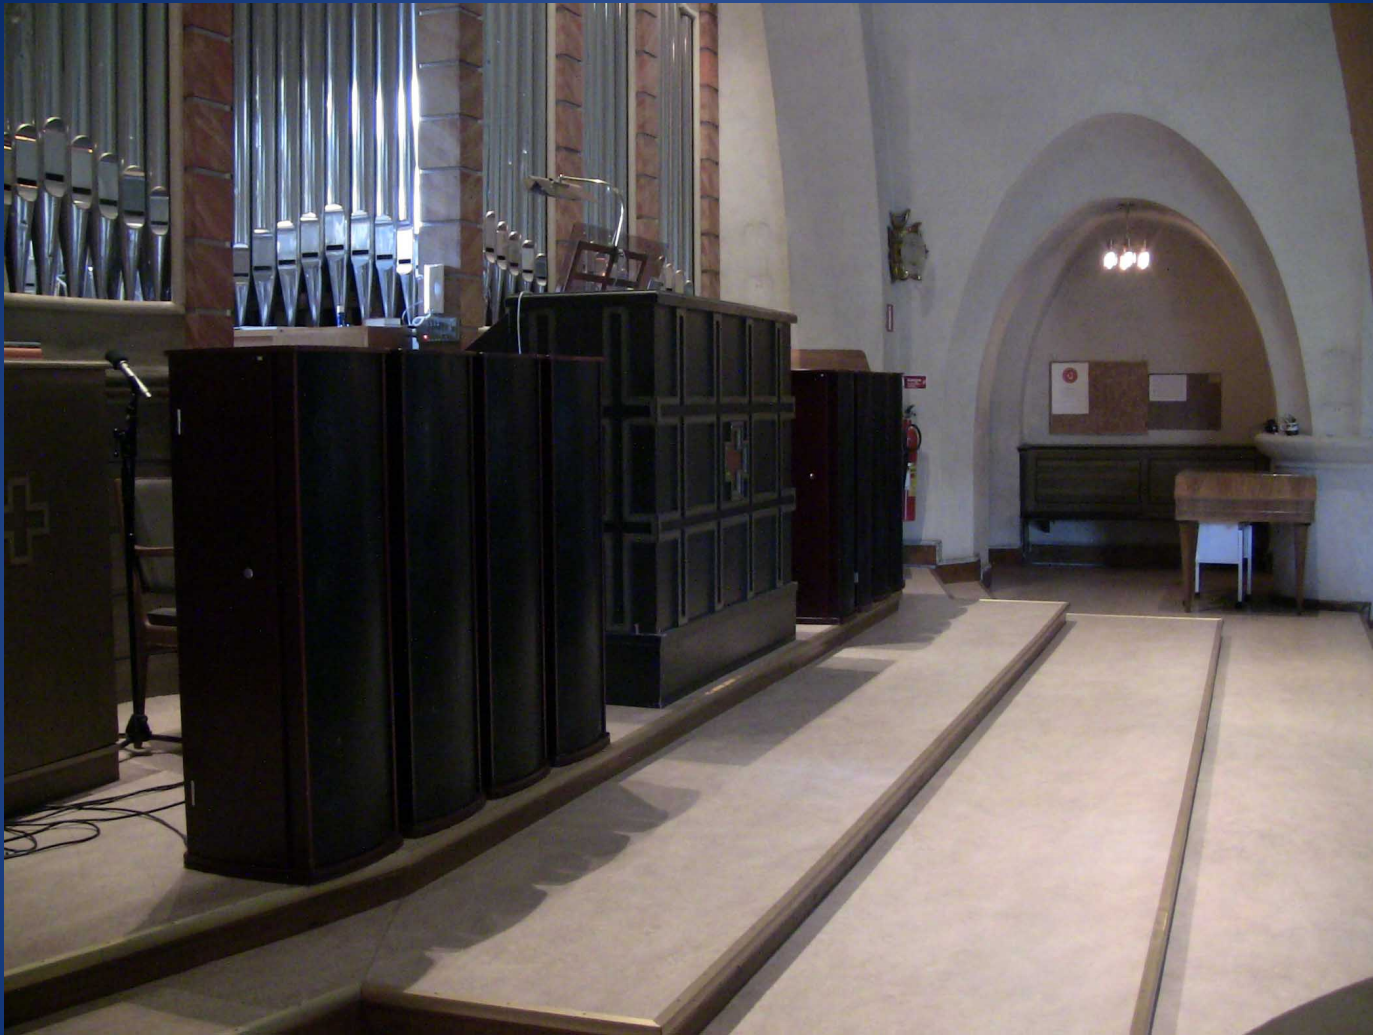
Particulate air cleaning: Eight stand-alone air cleaners assembled on the balcony of a church. Measurements have indicated effective reduction of the amount of airborne particles.

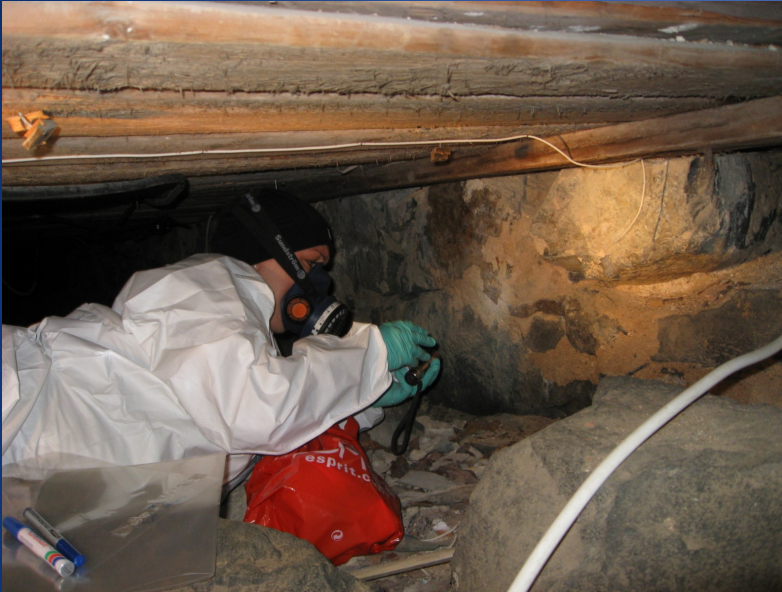
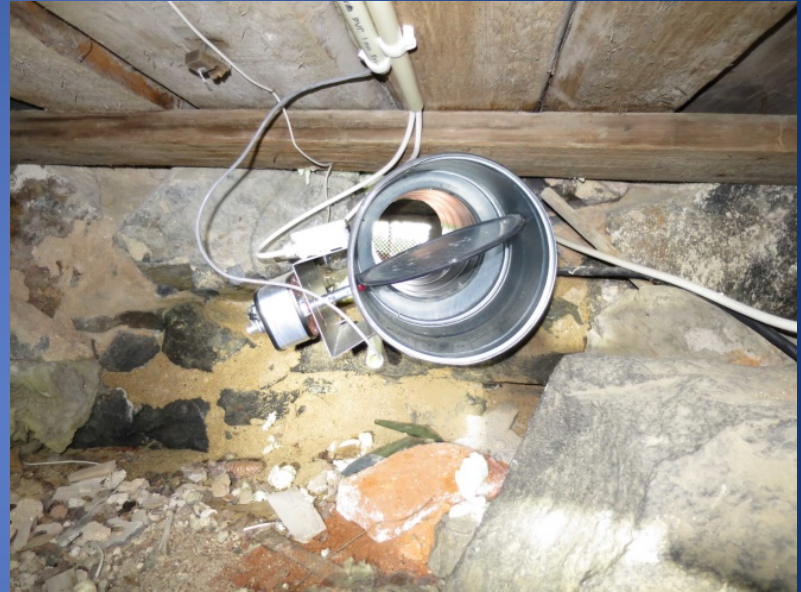
Crawl space ventilation strategies and effects on dampness are tested. On the right, a humidity-controlled damper in a crawl space vent.

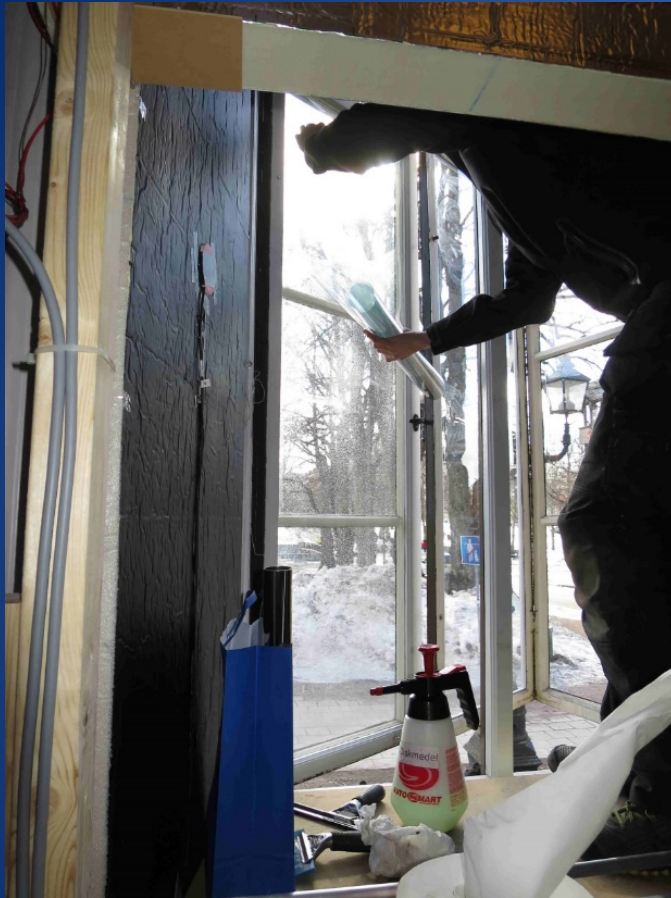
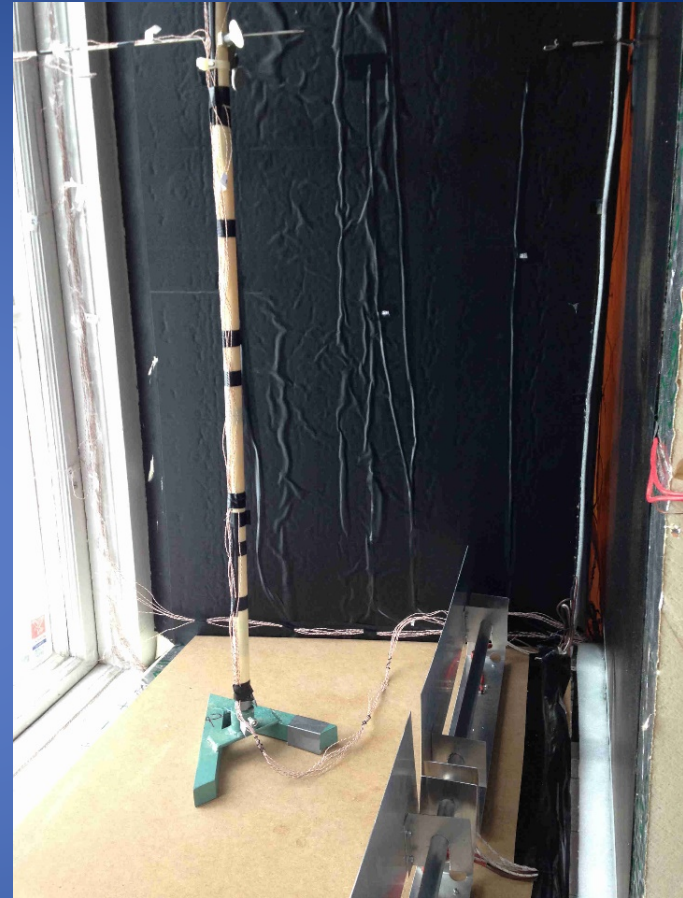
Low-emissivity film applied to window on Gävle municipal hall for reduced heat loss and improved thermal comfort. Installation tested with heat-box on site.
